# REPORT

## Marine 2019/08

## SUMMARY OF THE PART ONE REPORT ON THE COLLISION ON 8 NOVEMBER 2018 BETWEEN THE FRIGATE HNO MS HELGE INGSTAD AND THE OIL TANKER SOLA TS OUTSIDE THE STURE TERMINAL IN THE HJELTEFJORD IN HORDALAND COUNTY

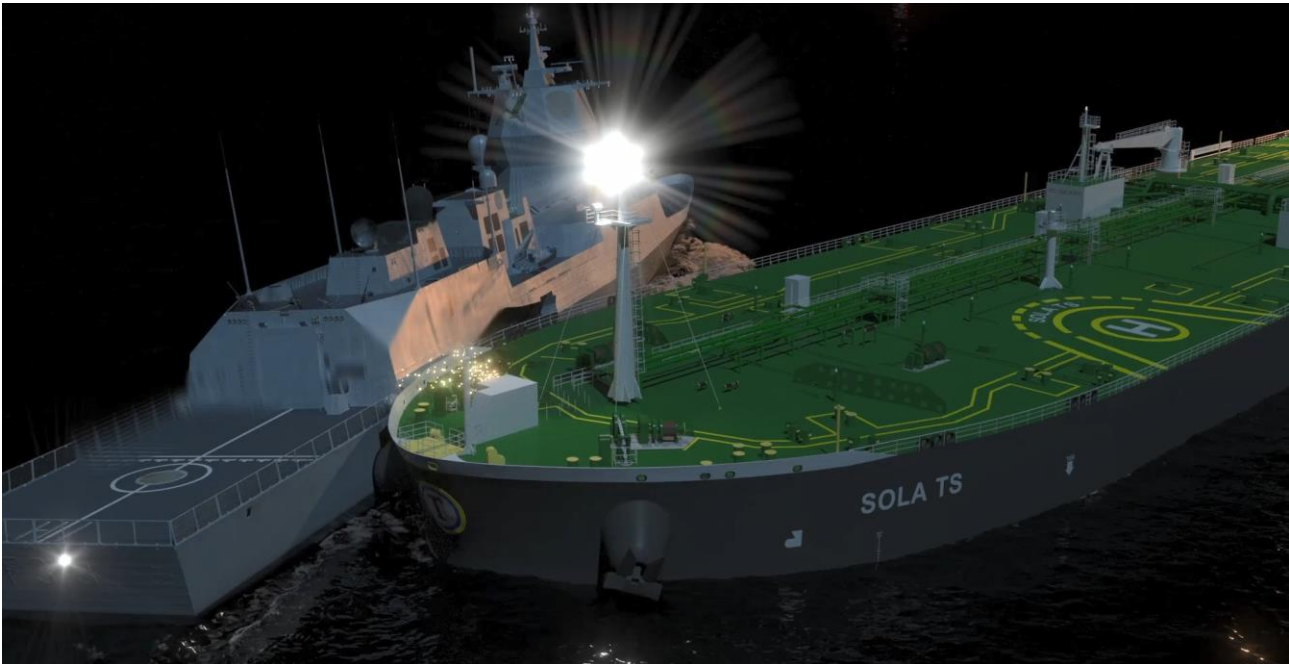
Figure 1: The point of impact when HNoMS Helge Ingstad and Sola TS collided outside the Sture Terminal in the Hjeltefjord at 04:01:15. Illustration: AIBN

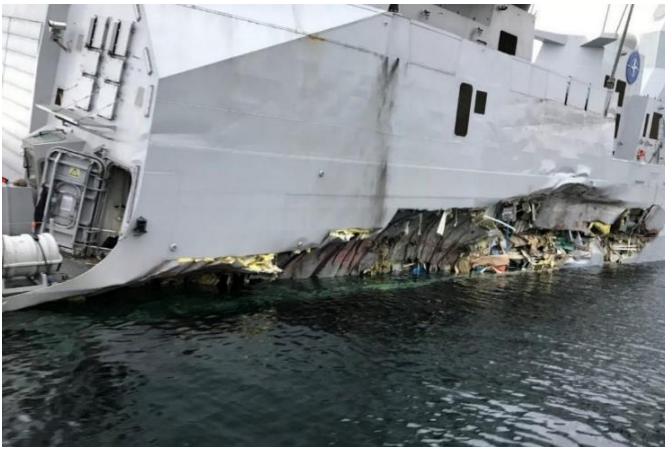
HNoMS Helge Ingstad suffered extensive damage along the starboard side. Seven crew members sustained minor physical injuries. Sola TS received minor damages in the bow area. Marine gas oil leaked out into the Hjeltefjord. The Institute of Marine Research has ascertained the effect of the oil spill had little impact on the marine environment.

Figure 4: Damage to the hull along the starboard side of HNoMS Helge Ingstad after the collision. Photo: The Norwegian Coastal Administration

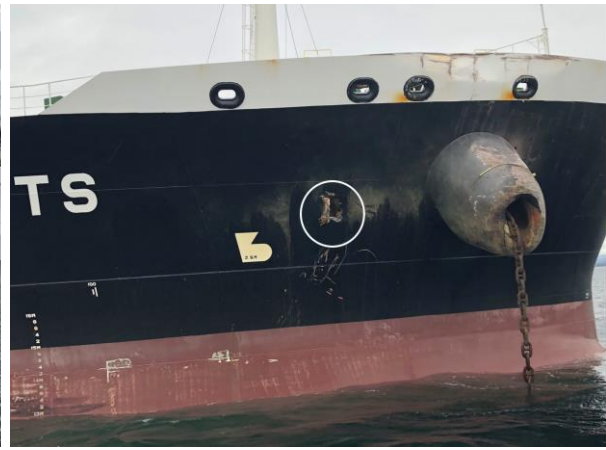
Figure 5: The hawsepipe and the damage sustained by Sola TS in the collision. The hole in the hull is marked with a white circle. Photo: The Norwegian Maritime Authority

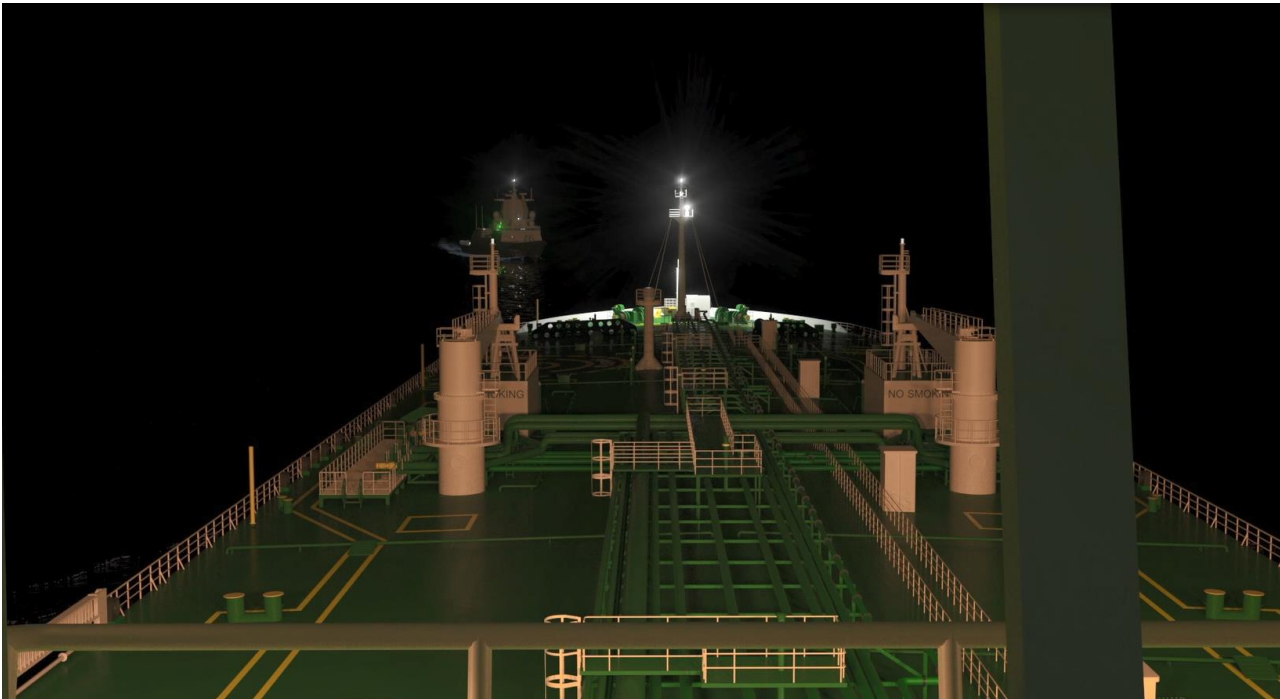
Figure 12: Illustrates the view from the bridge on Sola TS just before the collision. Illustration: AIBN
