# REPORT

## Marine 2019/08

## SUMMARY OF THE PART ONE REPORT ON THE COLLISION ON 8 NOVEMBER 2018 BETWEEN THE FRIGATE HNO MS HELGE INGSTAD AND THE OIL TANKER SOLA TS OUTSIDE THE STURE TERMINAL IN THE HJELTEFJORD IN HORDALAND COUNTY

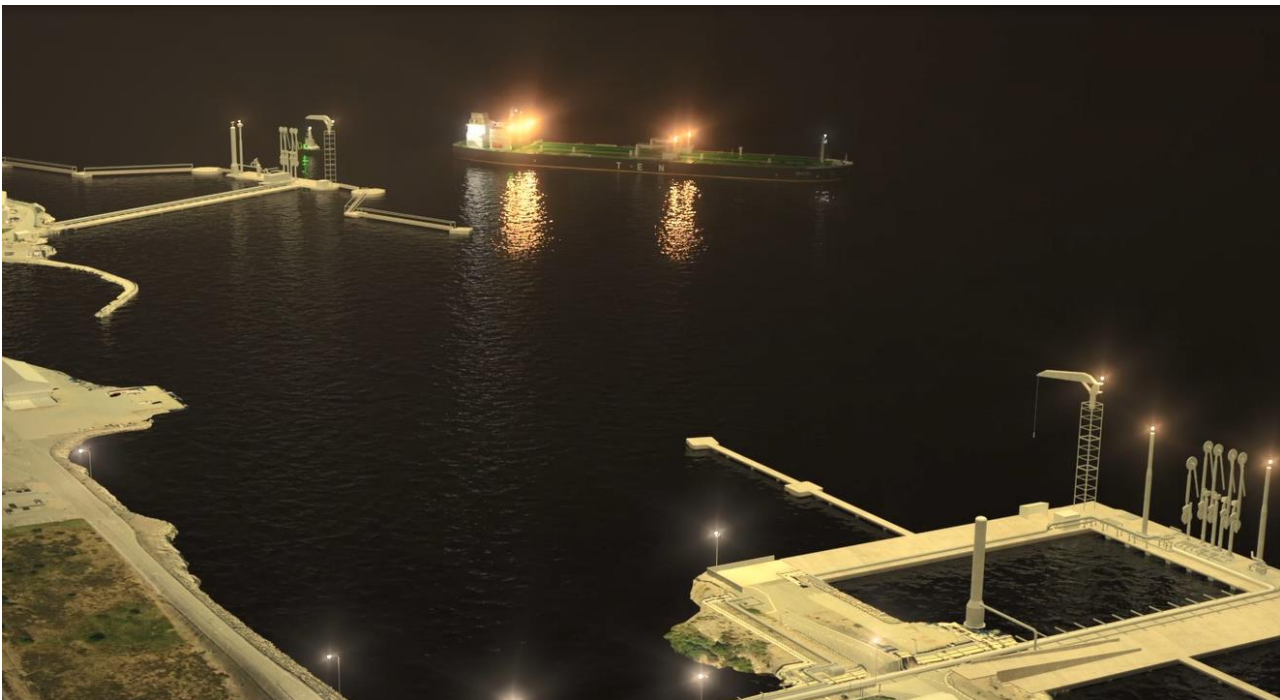
*Figure 6: Sola TS departed the Sture Terminal at 0345. The tanker was assisted by the two tugs Tenax and Ajax during the departure. Illustration: AIBN*

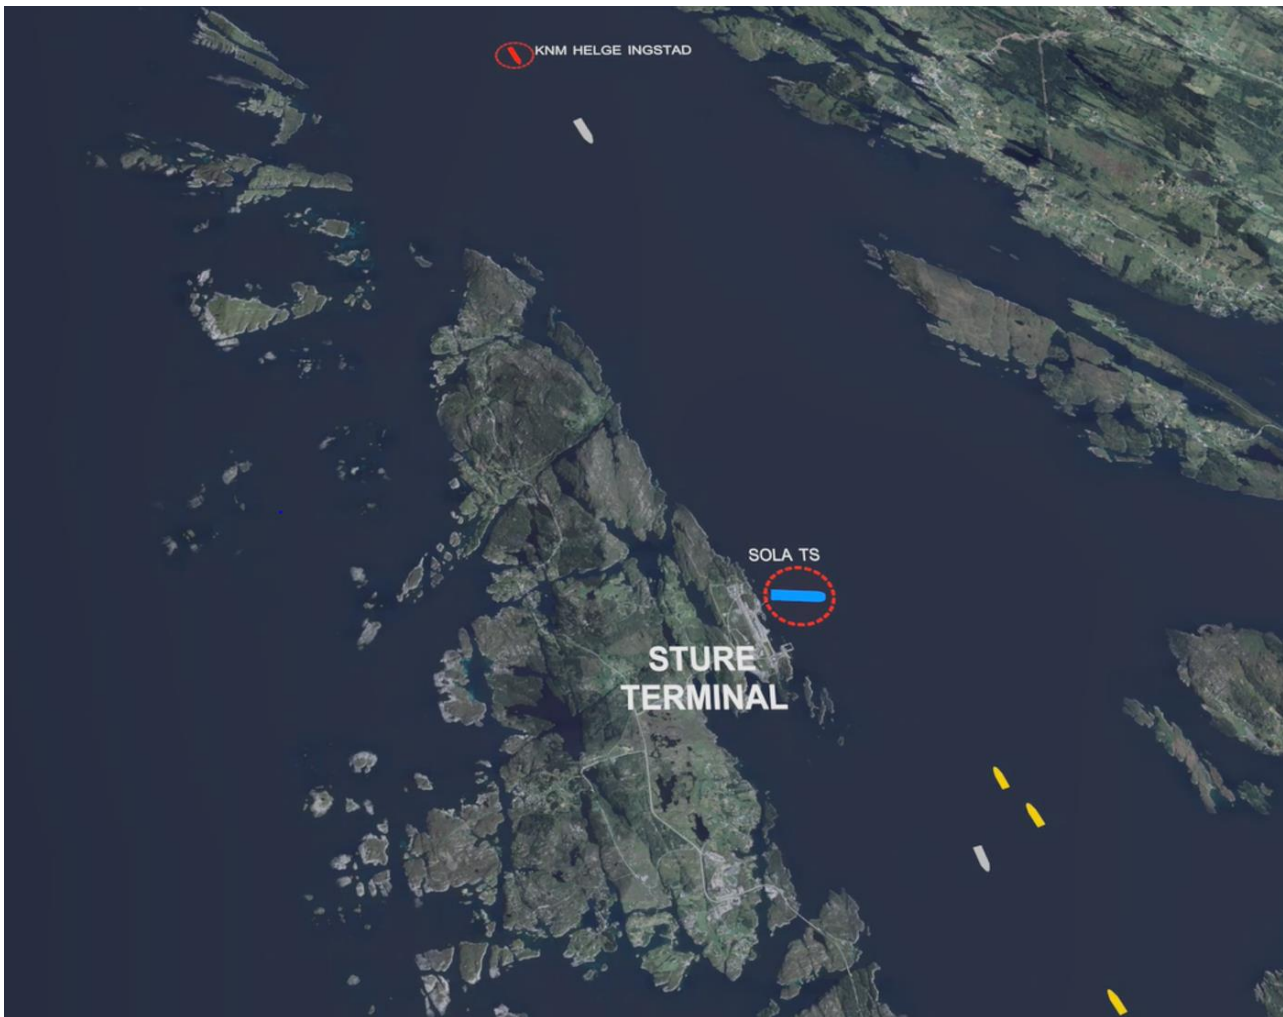
At the time of departure there were three northbound vessels approximately 2 – 3.5 nm south of the Sture Terminal. HNoMS Helge Ingstad was 5.8 nm north of the Sture Terminal, and outside the area that the VTS operator had zoomed in on, and was thus not part of the traffic situation being considered by the VTS operator. The VTS operator saw no need for traffic organisation or for issuing information to vessels in the area. Following the departure of Sola TS, the VTS operator's main work screen remained zoomed in on the area near the Sture Terminal. In the combination with

the lack of radar plotting, this contributed to the VTS operator not remembering HNoMS Helge Ingstad in the subsequent sequence of events.

Figure 7: The traffic situation in the Hjeltefjord at approximately 0345. The frigate had one southbound vessel just ahead, and three northbound and one southbound vessels south of the Sture terminal. Sola TS and the tugs Ajax and Tenax had now left the quay and started a port turn to set a northbound course towards Fedjeosen. HNoMS Helge Ingstad was directly to the east of Nordøyta, 5.65 nm to the north of Sola TS. Illustration: AIBN

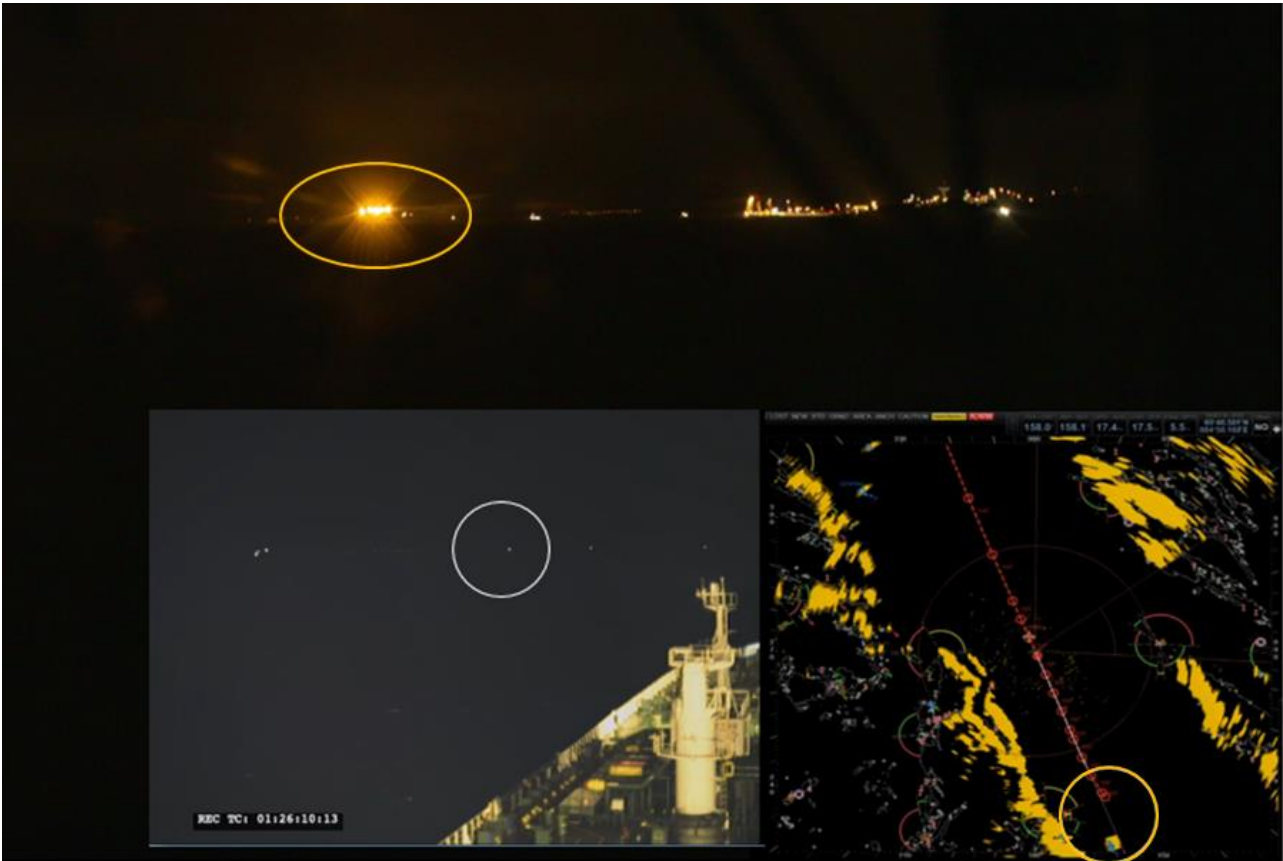
The officer of the watch eventually realised that the 'object' giving off light on the starboard bow was closer to the frigate's course line than first assumed. The officer of the watch has stated that the 'object' was primarily observed visually, but the officer of the watch had also seen on the radar that a little distance had appeared between the shore and the 'object'. The officer of the watch was still under the impression that this was a stationary object close to the Sture Terminal, that there was no room to pass between the 'object' and the terminal, and that the distance between the shore and the

'object' on the radar screen could be explained by the frigate having come closer to the point which the 'object' lay alongside.

Figure 9: Top: Screenshot of video recording on the bridge of HNoMS Roald Amundsen on the observation voyage in the early hours of 2 April 2019. This corresponds approximately to the situation at 03:53 on the night of the accident. Bottom left: Screenshot of video recording on the bridge of Sola TS on the observation voyage, HNoMS Roald Amundsen marked with white circle. Bottom right: Screenshot of video recording of the radar display on HNoMS Roald Amundsen on the observation voyage, Sola TS marked with yellow circle. Illustration: The shipping company/police/AIBN

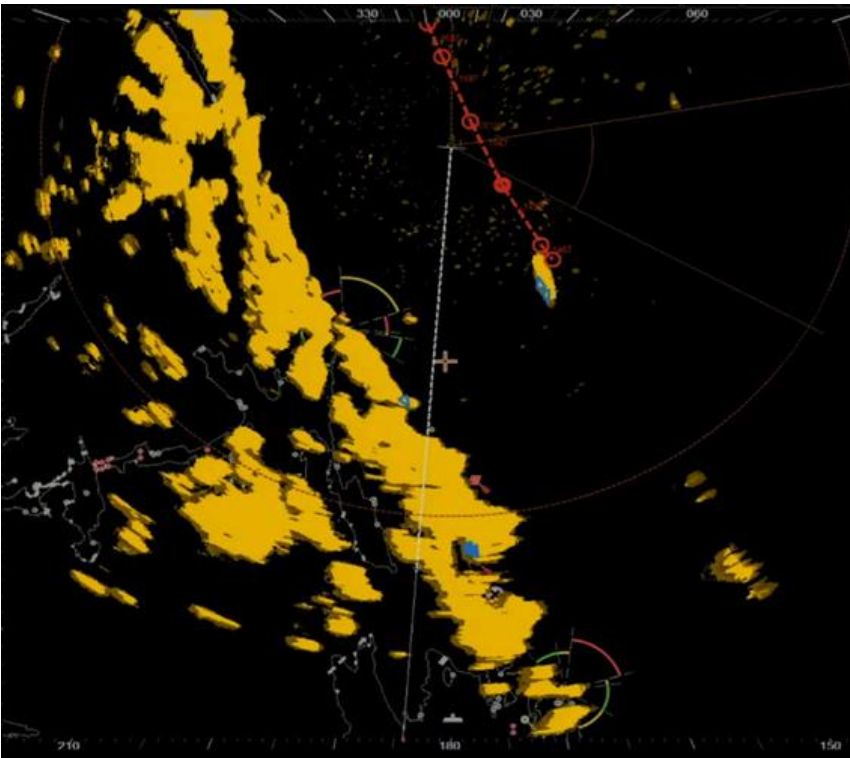
*Figure 10: Screenshot of video recording of the radar display on HNoMS Roald Amundsen during the observation voyage in the early hours of 2 April 2019, with the range scale set to 1.5 nm. This corresponds approximately to the situation at 03:59 on the night of the accident, when the distance between Sola TS and shore (Ådnesflua) was approximately 950 meters. Photo: The police*
